Monitoring Data Record

Project Title: R-977A US 64 COE Action ID: 2005301150
 Stream Name: UT to Hiwassee River (Site 11) DWQ Number: 3487
 City, County and other Location Information: Murphy, Cherokee County, US 64, from
US 19-74-129 in Murphy to East of NC 141 in Peachtree (Sta. 12+20 to 15+50)
 Date Construction Completed: March 2007 Monitoring Year: (2) of 5
 Ecoregion: 8 digit HUC unit 06020002
 USGS Quad Name and Coordinates: _____

Year 2 Winter – March 2009

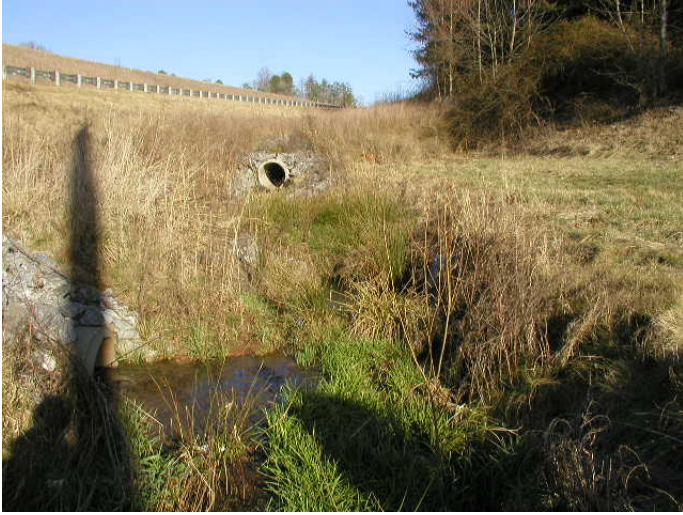
Photo Point #1 (Upstream)

The buffer area upstream of the church driveway culvert (Photo Points 1 through 4) has continued to be mowed. Planted vegetation was minimal along this section of the stream relocation at the time of the evaluation. Some of the planted vegetation below the church driveway has also been mowed.

Estimated causes, and proposed/required remedial action: NCDOT plans to notify the church again about not mowing this area and to install white top stakes to show contractors the mowing limits. Replanting of the entire stream relocation should be completed by April 2009.

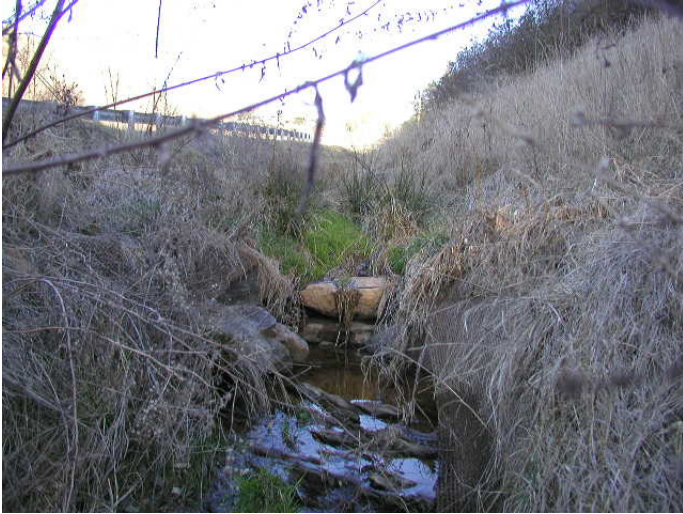
Photo Point #7 (Upstream)

Date Inspected 3/4/09	Station 13+20 PP#7 Upstream and Downstream Photo	Station 13+00 PP#8 Upstream Photo	Station 13+40 to 13+80 Between PP#5 and PP#6	Station Number	Station Number
Structure Type	Crossvane	Crossvane			
Is water piping through or around structure?	Water piping under crossvane	Water piping under crossvane	Water piping bypassing stream bed underground where blasting took place		
Head cut or down cut present?					
Bank or scour erosion present?					
Other problems noted?
